VMI-3300

3" In-Line Check Valve

- Maintain Line Pressure
- Prevent MLLD Slow Flow
- Slash Repair Costs
- Easy Access for Future Check Valve Replacement
- 15 psi Relief Valve

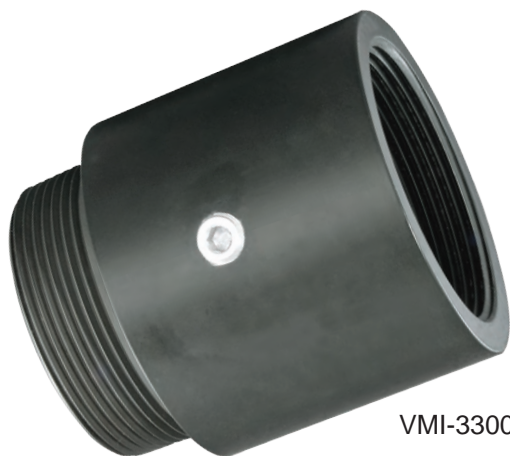
VMI-3300

A failing check valve in a 3hp or 5hp STP requires a two-man crew and a crane to pull the STP in order to access the check valve, a very costly repair. The **VMI-3300** 3" In-Line Check Valve is a great retrofit solution to reduce service costs. The **VMI-3300** installs in the STP discharge, the LD-3000 High Capacity Line Leak Detector installs in the outlet of the **VMI-3300**. Installed in this manner, the **VMI-3300** maintains pressure upstream of the LLD. This economical solution means there is no need to replace a failed STP check valve.

No affect to MLLD flow throughput. All orifices are the same size or larger than those of the LD-3000.

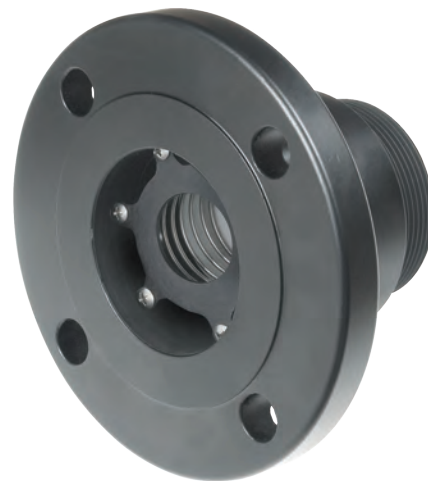
VMI-3300\FL

3" In-Line Check Valve, Flanged

The **VMI-3300\FL** is recommended for applications where the benefits of a flanged installation are desired. The flange on the outlet of the **VMI-3300\FL** mates with the flange of the LD-3000\FL inlet, further reducing future service costs.
